HOLE-TYPE NOZZLES  
WITH RESTRICTED  
SPRAY ORIFICES

Workshop: EP  
02.1992  
0311 En

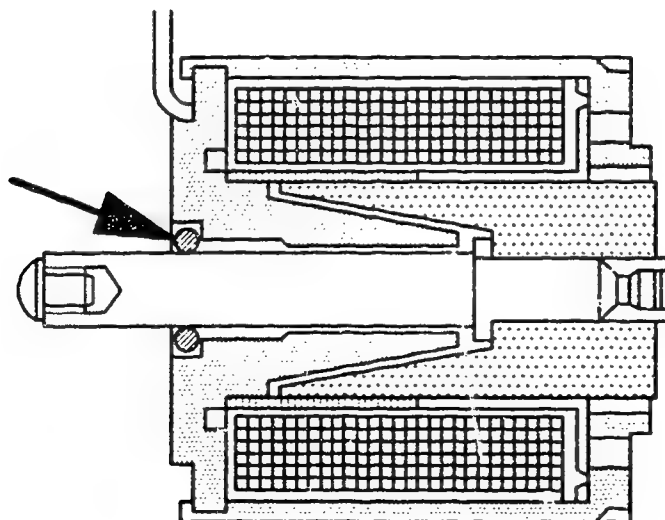
KMK02236

In the area of the bearing bore for the electromagnet-armature thrust pin, new adjusting magnets feature an O-ring in a groove to stop the electromagnet armature dropping out (picture - arrow).

This O-ring must be removed before installing a new adjusting magnet. The required magnet freedom of movement is not guaranteed with the O-ring in position.

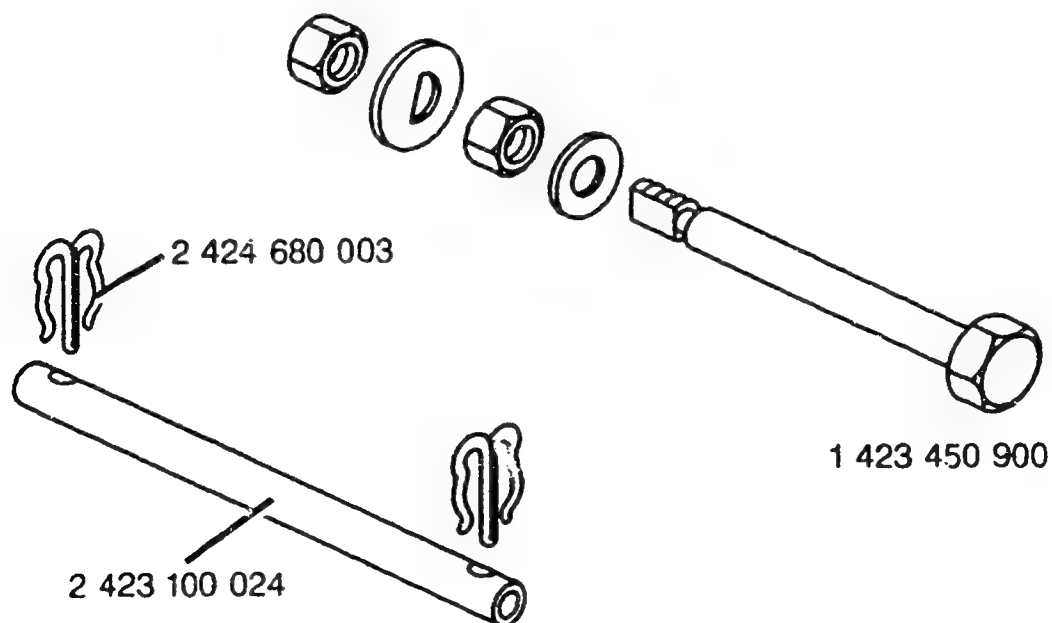
KMK02602

Recent product releases have included  
flywight assemblies that employ a new  
cross-bolt design (see illustration).

If the governor you are serving is  
equipped with the new cross-bold design  
DO NOT USE PARTS SET 1 423 450 900 AS  
A REPLACEMENT.

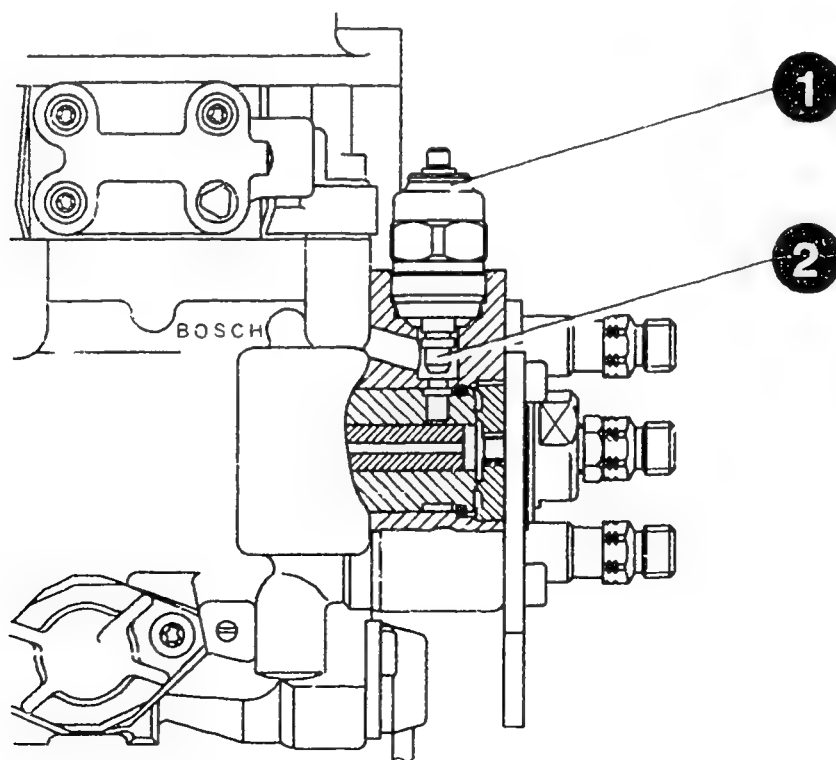
KMK02765

- \* Red plastic encapsulation of  
electrical connection (1)
- \* Check valve in electromagnet  
armature (2) (holes on end face  
and on side at end)

If a different ELAB is fitted, this must be replaced by an ELAB with RSV.

If there is no check valve in the electromagnet armature, the complete ELAB is to be replaced by an ELAB with RSV.

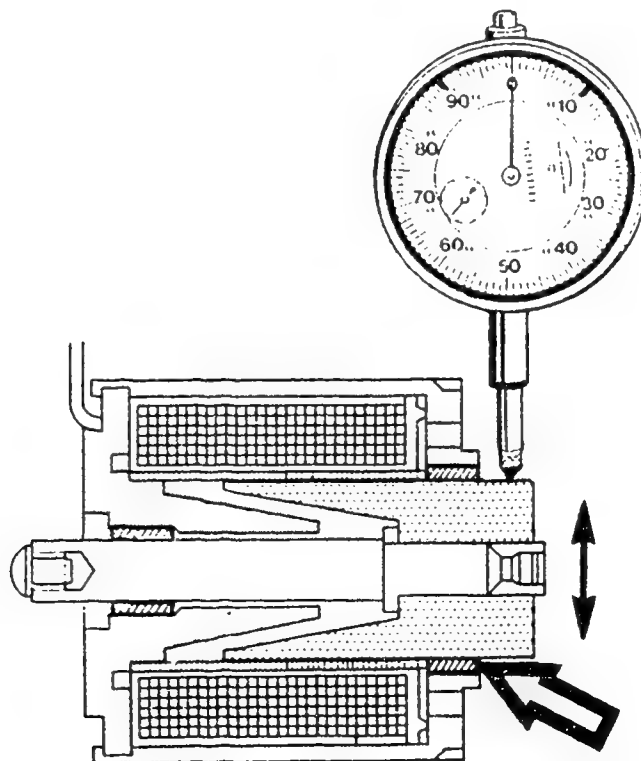
KMK 03078

The problem is usually caused by a stiff electromagnet armature in the adjusting magnet of the RE positioner due to one-sided wear of the large electromagnet-armature bushing (picture, arrow).

Such wear cannot be detected during normal testing of the IP assembly on an IP test bench. For this reason, should such complaints be received, the adjusting magnet is to be removed and the bearing wear measured.

- Completely remove positioner cover.
- Unsolder electrical connections of control-rod-travel sensor and adjusting magnet at connection plate (pay attention to soldering specifications).
- Remove control-rod-travel sensor and adjusting magnet.
- Check large bushing in adjusting magnet (arrow) for wear.

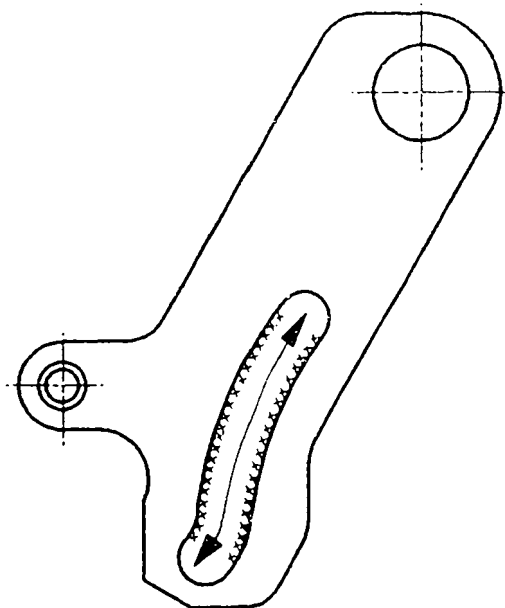
KMK01710

The cam need not be renewed if there are shiny areas in the working area of the driving pin, but no noticeable scoring.

The cam is to be renewed if one of the two situations outlined above is encountered.

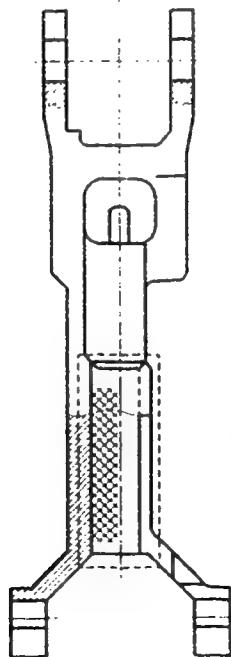
KMK01711

1. Heavy scoring or material abrasion in working area of variable-fulcrum lever guide
2. Pocket-like wear in working area of variable-fulcrum-lever guide

The variable-fulcrum lever need not be renewed if there is slight tracking, but no noticeable scoring, in the working area of the variable-fulcrum-lever guide.

The variable-fulcrum lever is to be renewed if one of the two situations outlined above is encountered.

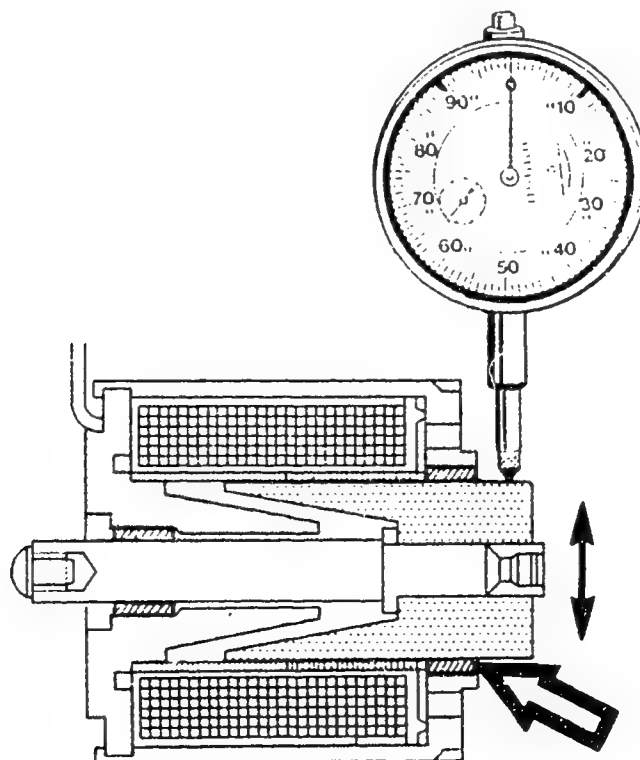
KMK 03078

This complaint may be due to a stiff armature in the RE-positioner solenoid resulting from (usually one-sided) wear of the large armature bushing (picture, arrow).

Normal testing of the IP assembly on an IP test bench does not reveal such wear. When confronted with the above complaint, the solenoid is therefore to be removed and the bearing wear measured.

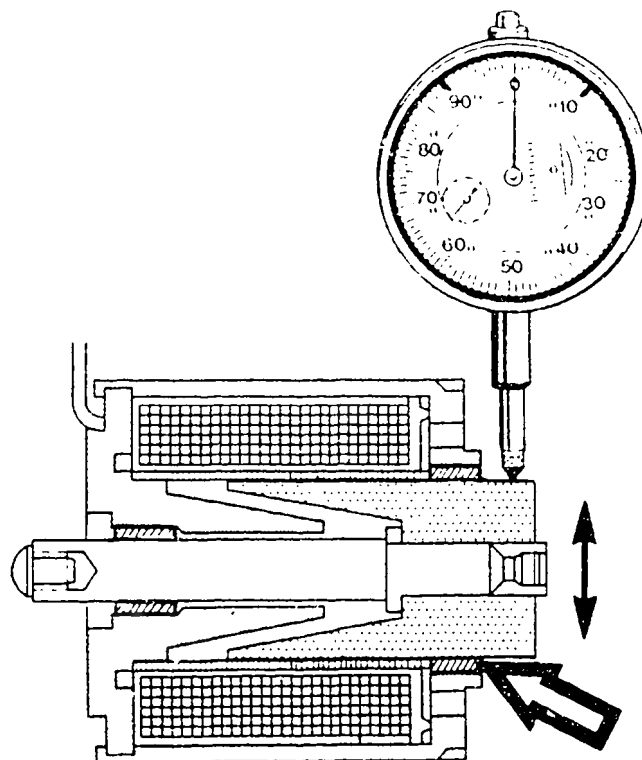
KMK 03078

Procedure: Place magnet in prism.  
Pull electromagnet armature somewhat  
out of housing and align dial  
indicator at armature directly  
adjacent to large bushing. Move  
armature in vertical direction within  
bearing clearance; in doing so, turn  
magnet in prism to several positions  
and establish maximum bearing  
clearance.

The clearance for the large bushing must not exceed 0.15 mm.

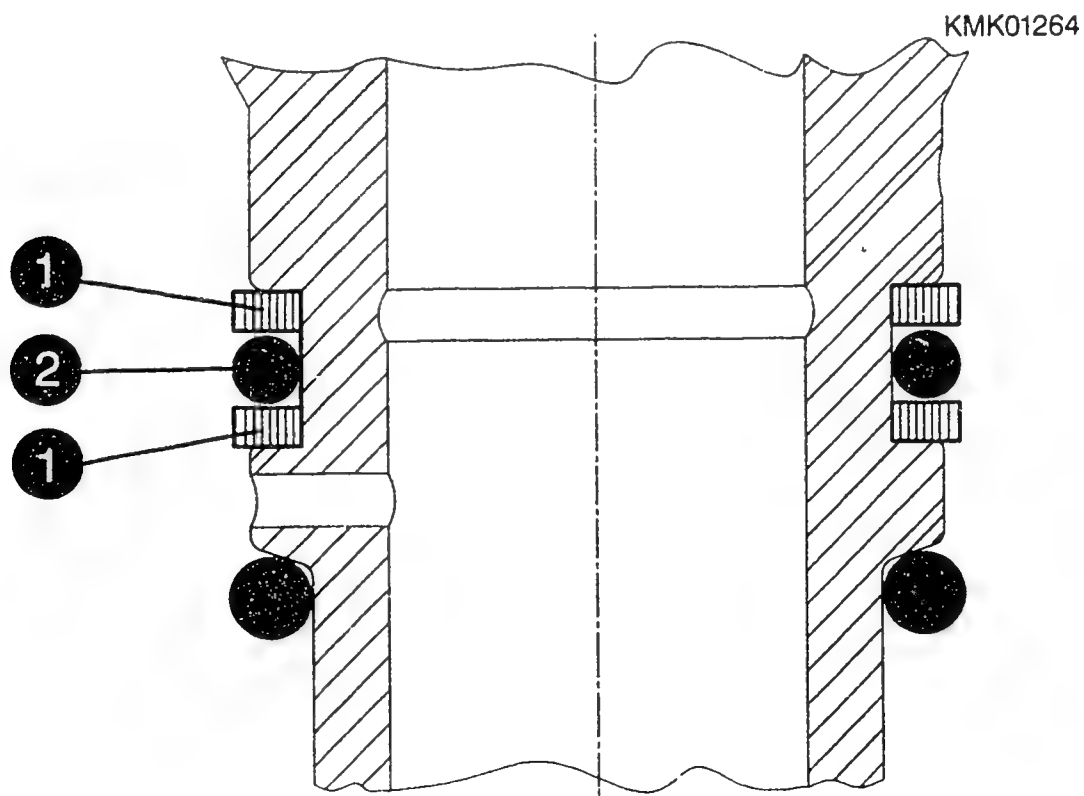
The slotted support rings used to date are being replaced in the course of the current series by solid support rings.

Check whether support ring (1)/  
O-ring (2)/support ring (1) are  
correctly positioned as shown.

- \* When performing repairs, support rings and O-rings already fitted are to be replaced with new ones.
- \* Support rings which collapsed on assembly are to be replaced with new ones.
- \* Pump housings and plunger-and-barrel assemblies of old (slotted support ring) and new (solid support ring) versions are identical. Slotted support ring can therefore simply be replaced by solid type.

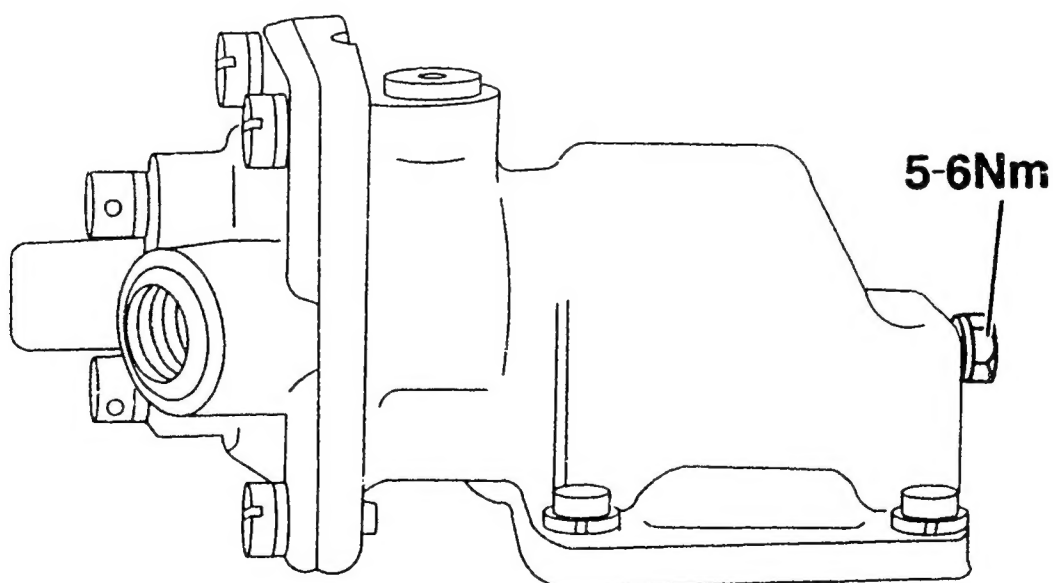
KMK04725

When performing starting fuel quantity adjustments on P-7100 injection pump combinations using top-mounted LDA assemblies, be certain to apply the correct torque to the locking screw and ensure that there is full movement capacity of the stop part after doing so. The specified torque of the locking screw is 5...6 Nm (see illustration).
